Magnom® Filtering Lubrication System

Petri Korhonen – Condition Monitoring Specialist
Cold Reduction Department
Western Port Works

The Condition Monitoring Department at Cold Reduction conducted a filtration trial on the Five Stand Mill (FSM) Motor Generator Set lubrication system.

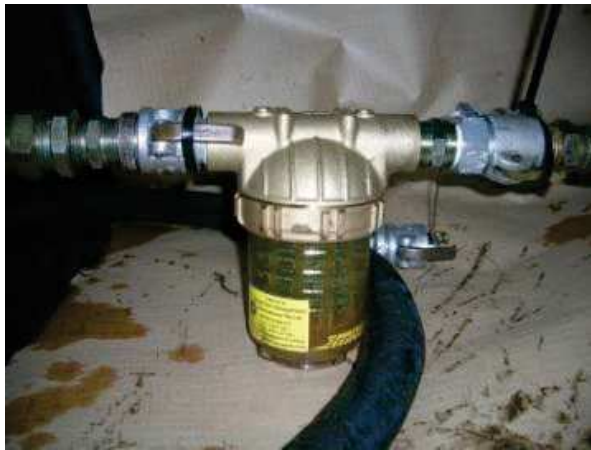
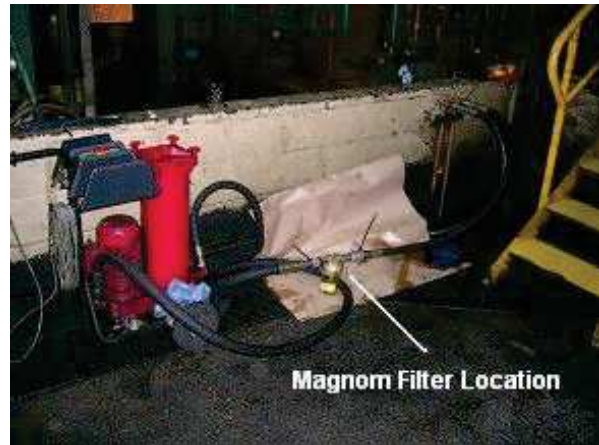
A filter cart was used to polish the oil in a kidney loop arrangement, installed with a 3 micron $\beta_3 \geq 100$ Filter.

A Magnom® filter (Magnetic Core) was also connected as a pre-filter to the filter cart.

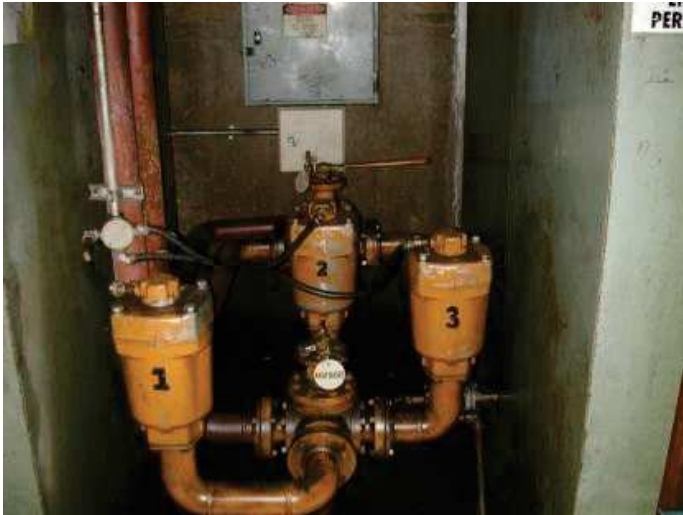
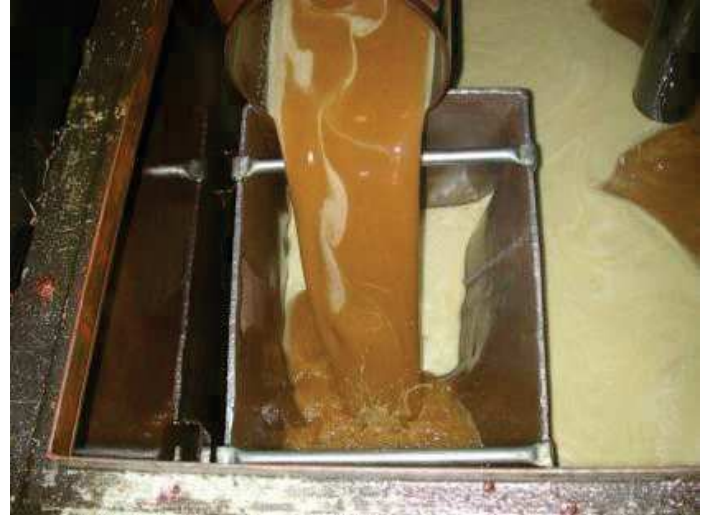
MG set white metal journal bearings with running clearance of 125 microns.
MG Set lubrication system contains several filters at different stages.
Ranging from 10 micron to 250 Mesh.

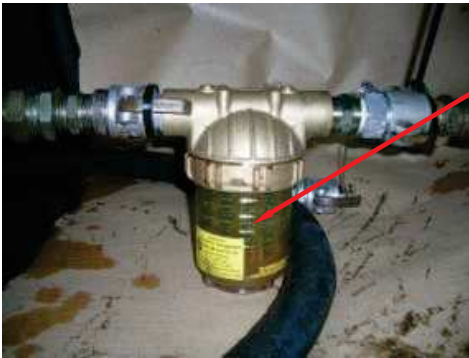
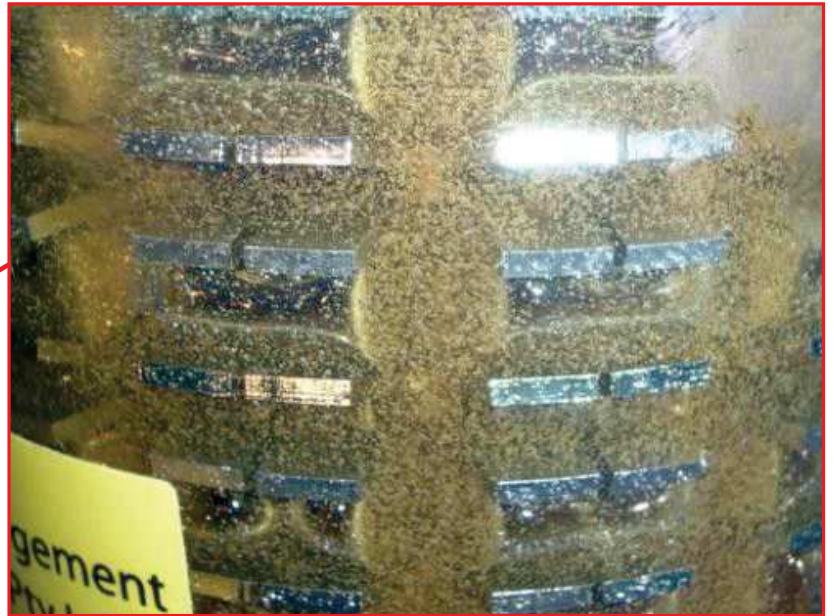
The clear bowl of the Magnom® filter allows ease of inspection (depending on fluid clarity). Here the lubricating oil BP Bartran 46 can be seen passing the magnetic core.

The fluid looks heavily air entrained !

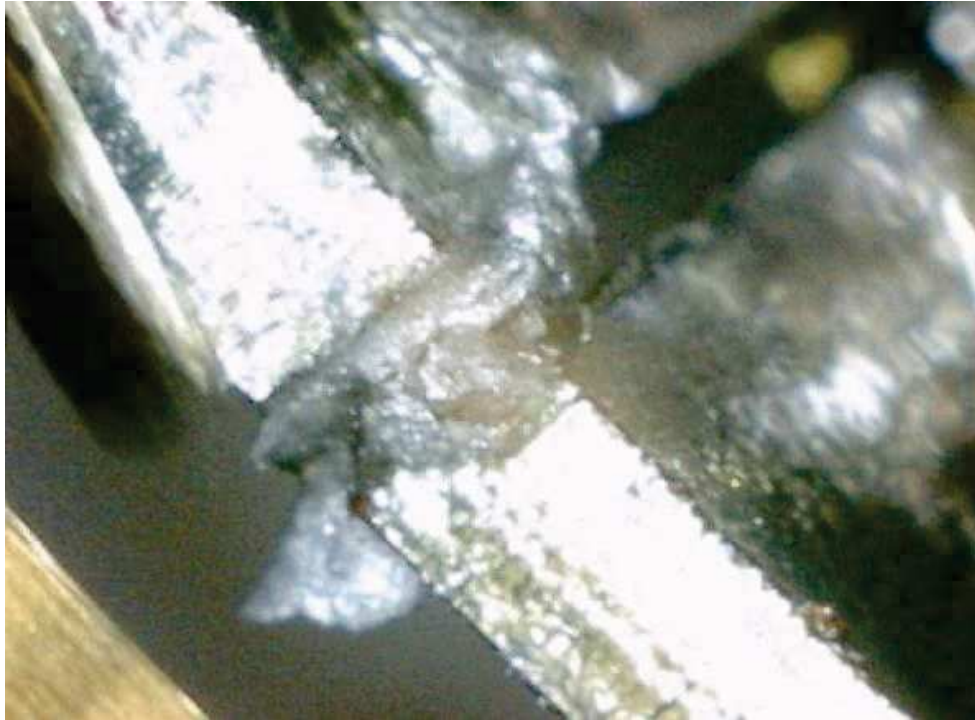
The Magnetic Core of the Magnom® filter also captured very fine ferrous particles.

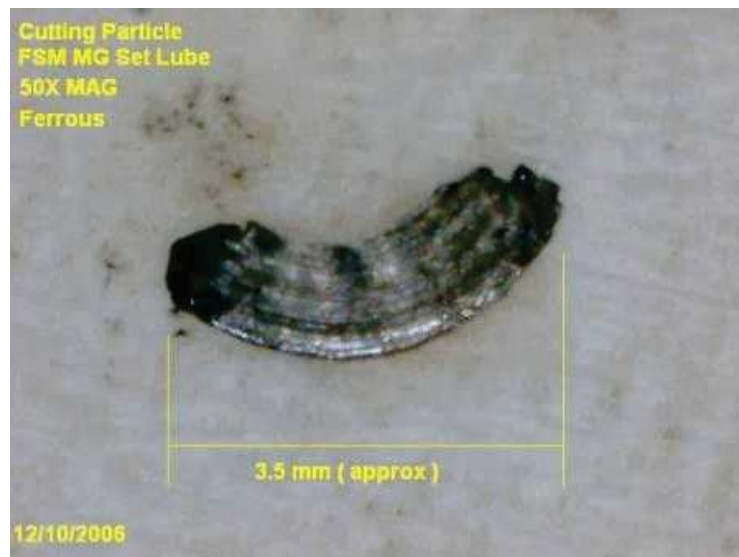
The microscope view of this particle shows defined cutting lines, tempering color and curling.

A large particle of 3.5 mm size found in the MG Set lubrication system is of serious concern.

The origin of the particle is unknown, but there had been some maintenance activity about 2 years prior, which involved hatch installation because the system was not sealed sufficiently to prevent contamination. This could be drill swarf from the hatch installation.
